APOLLO 11 MISSION REPORT

MANNED SPACECRAFT CENTER
HOUSTON, TEXAS
NOVEMBER 1969

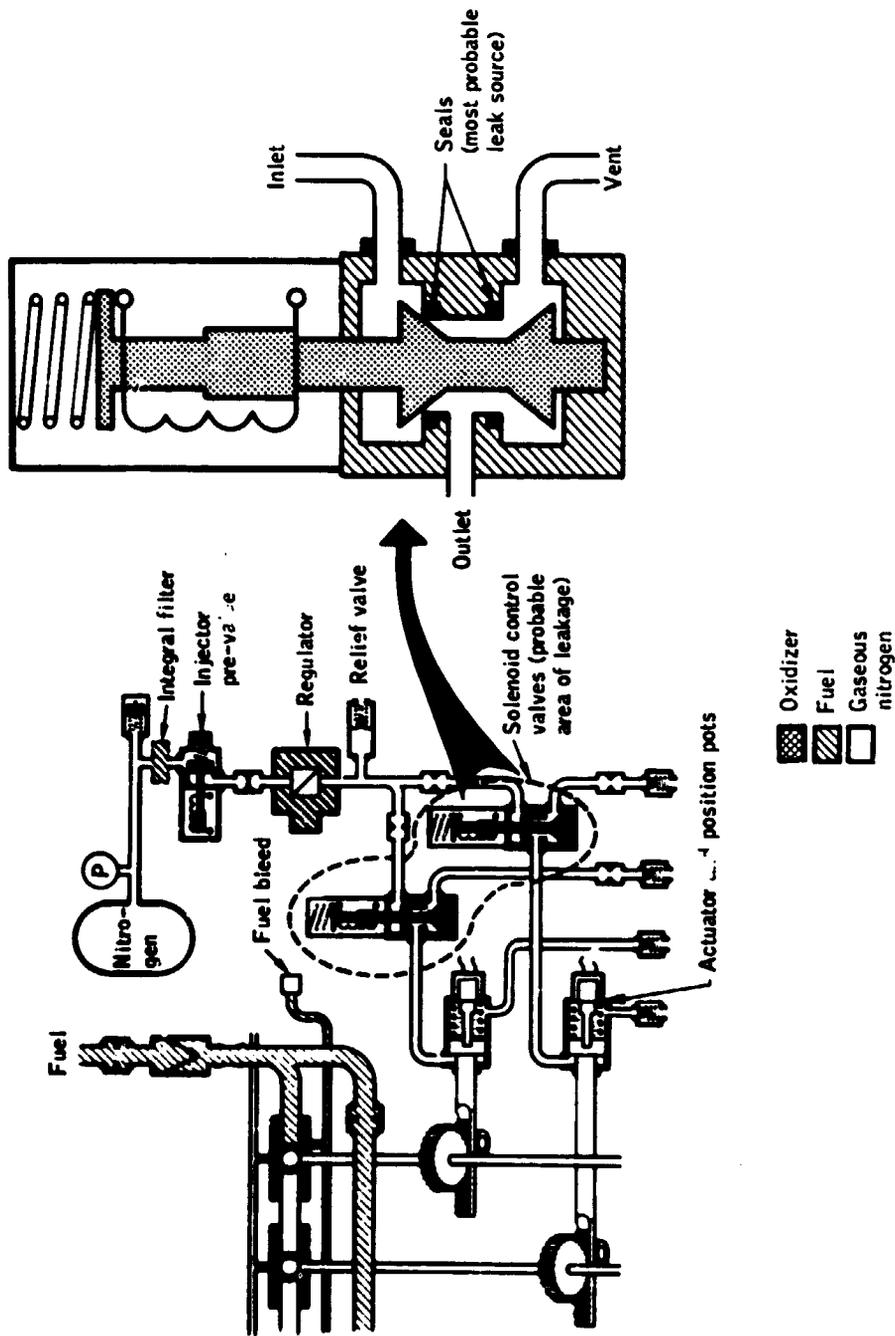
Figure 16-2.- Control for service propulsion propellants.

The fuel and oxidizer valves are controlled by actuators driven by nitrogen pressure. Figure 16-2 is representative of both nitrogen control systems. When power is applied to the service propulsion system in preparation for a maneuver, the injector pre-valve is opened; however, pressure is not applied to the actuators because the solenoid control valves are closed. When the engine is commanded on, the solenoid control valves are opened, pressure is applied to the actuator, and the rack on the actuator shaft drives a pinion gear to open the fuel and oxidizer valves. When the engine is commanded off, the solenoid control valve vents the actuator and closes the fuel and oxidizer valves.

It is concluded that the leakage was due to a contamination-induced failure of a solenoid control valve. The source of contamination is unknown; however, it was apparently removed from the sealing surface during the valve closure for the first lunar orbit insertion maneuver (fig. 16-2). A highly suspect source is a contaminated facility manifold at the vendor's plant. Although an investigation of the prior failure indicated the flight valve was not contaminated, the facility manifold is still considered a possible source of the contaminants.

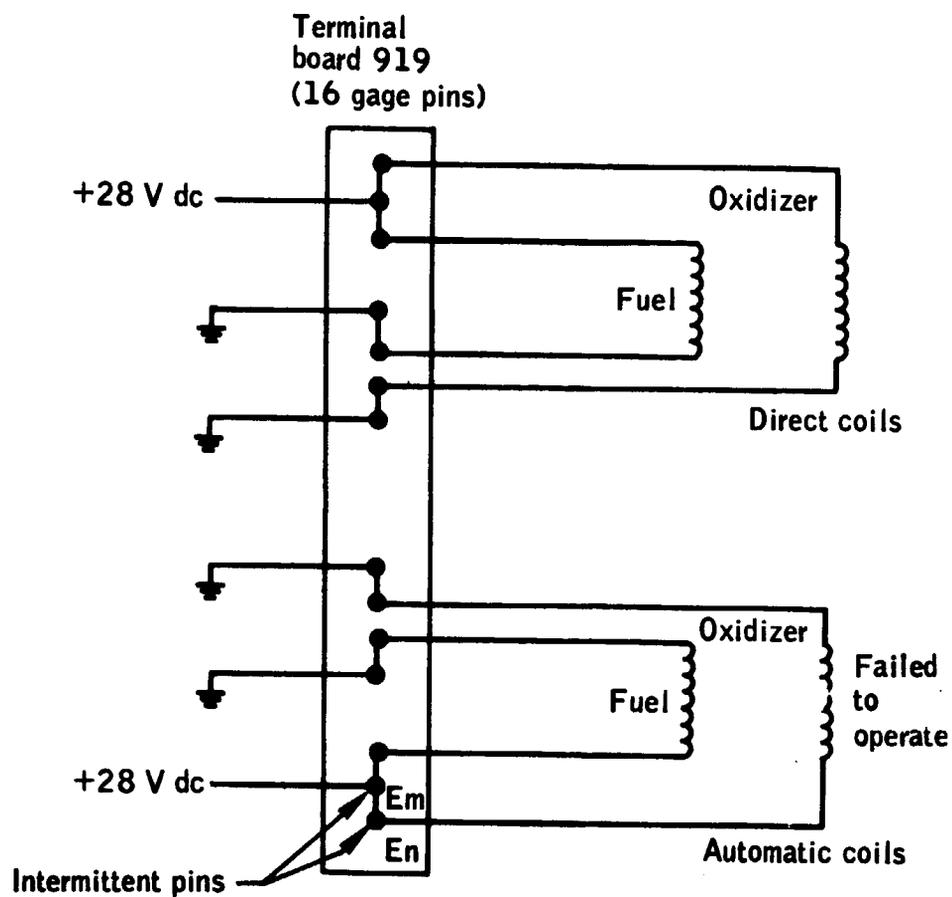
Figure 16-3.- Terminal board schematic for minus-yaw engine, command module reaction control system 1.

Postflight tests showed that two pins in the terminal board (fig. 16-3) were loose and caused intermittent continuity to the automatic coils of the engine valve. This type failure has previously been noted on terminal boards manufactured prior to November 1967. This board was manufactured in 1966.

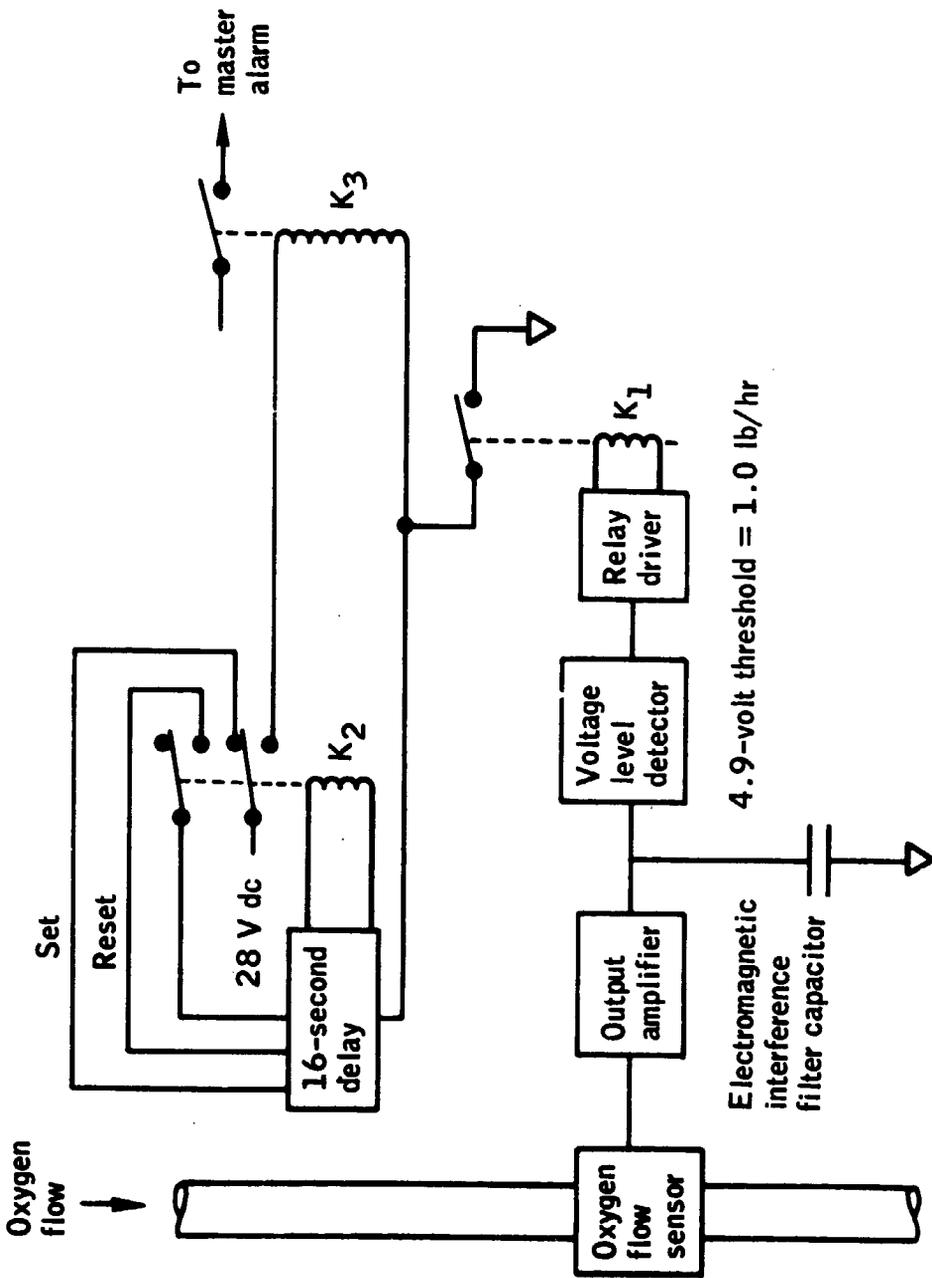
Figure 16-4.- Oxygen flow sensing circuit.

During the initial lunar module pressurization, two master alarms were activated when the oxygen flow rate was decreasing from full-scale. The same condition had been observed several times during altitude-chamber tests and during subsequent troubleshooting. The cause of the problem could not be identified before launch, but the only consequence of the alarms was the nuisance factor. Figure 16-4 shows the basic elements of the oxygen flow sensing circuit.

Note in figure 16-4 that in order for a master alarm to occur, relay K1 must hold in for 16 seconds, after which time relays K2 and K3 will close, activating a master alarm.

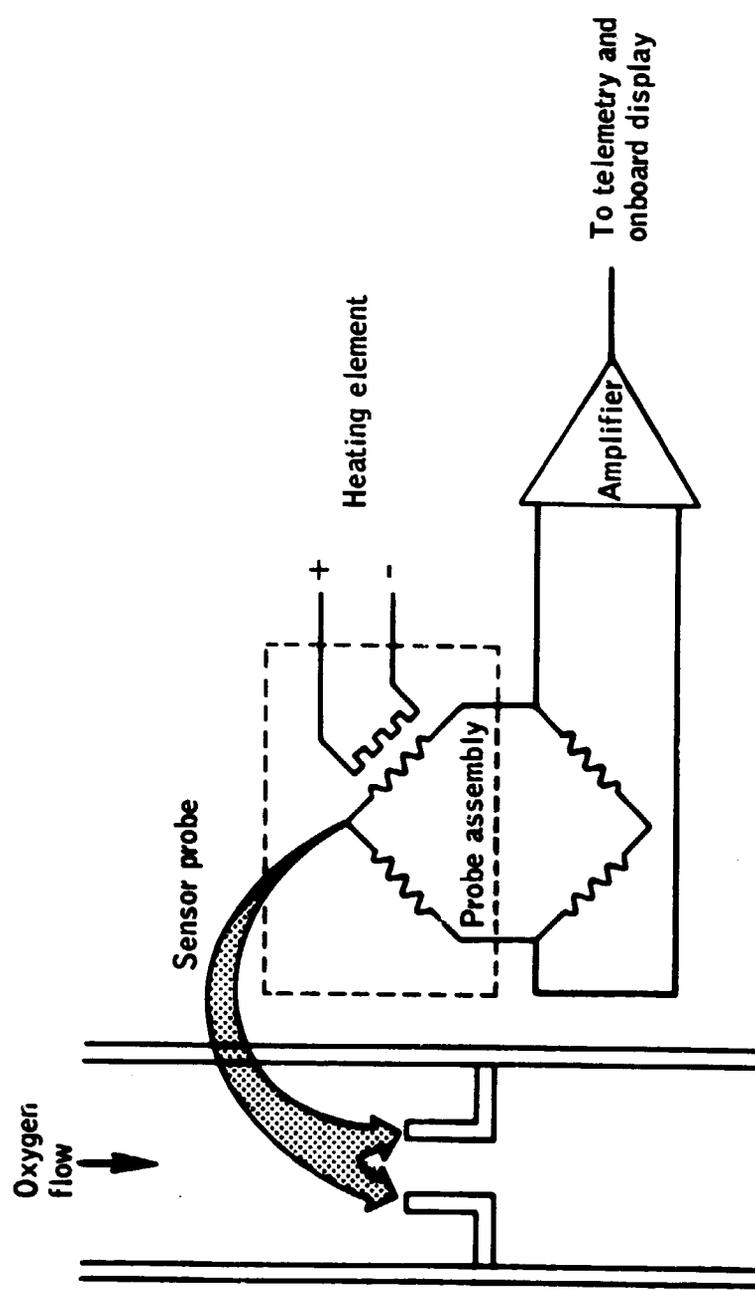
Figure 16-5.- Oxygen flow sensor.

Analysis of associated data indicated that the oxygen flow was normal, but that the indicated flow rate was negatively biased by approximately 1.5 lb/hr. Postflight tests of the transducer confirmed this bias, and the cause was associated with a change in the heater winding resistance within the flow sensor bridge (fig. 16-5). The resistance of the heater had increased from 1000 ohms to 1600 ohms, changing the temperature of the hot wire element which supplies the reference voltage for the balance of the bridge. Further testing to determine the cause of the resistance change is not practical because of the minute size of the potted resistive element. Depotting of the element would destroy available evidence of the cause of failure. Normally, heater resistance changes have occurred early in the 100-hour burn-in period when heater stability is achieved.

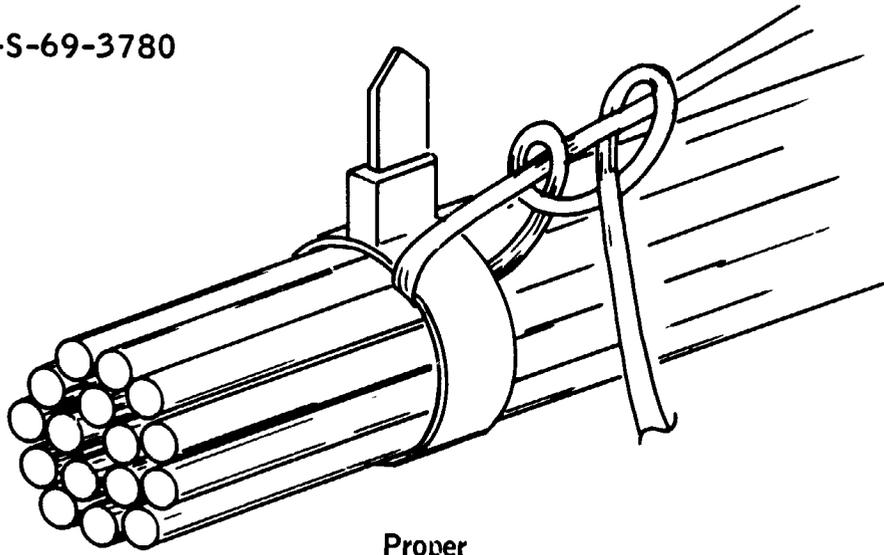
Figure 16-6.- Tie-wraps on lanyards.

The knots should be two closely tied half-hitches which secure the tie-wrap to the lanyard (fig. 16-6). Examination of the Apollo 10 lanyard indicates that these knots were not two half-hitches but a clove hitch (see figure). After the lanyard breaks the tie-wraps, if the fragment of tie wrap pulls out of the knot, the clove hitch knot can untie, thus lengthening the lanyard. Lengthening this lanyard as the umbilical cable pays out can allow transfer of some loading into the umbilical disconnects. Should a sufficient load be transferred to the disconnect fitting to cause shear pins to fail, a disconnect of the forward heat shield mortar umbilical could result prior to the mortar firing. This would prevent deployment of the forward heat shield separation augmentation parachute, and there would be a possibility of forward heat shield recontact with the command module. Examination of the forward heat shield recovered from Apollo 10 confirmed that the mortar had fired and the parachute was properly deployed.

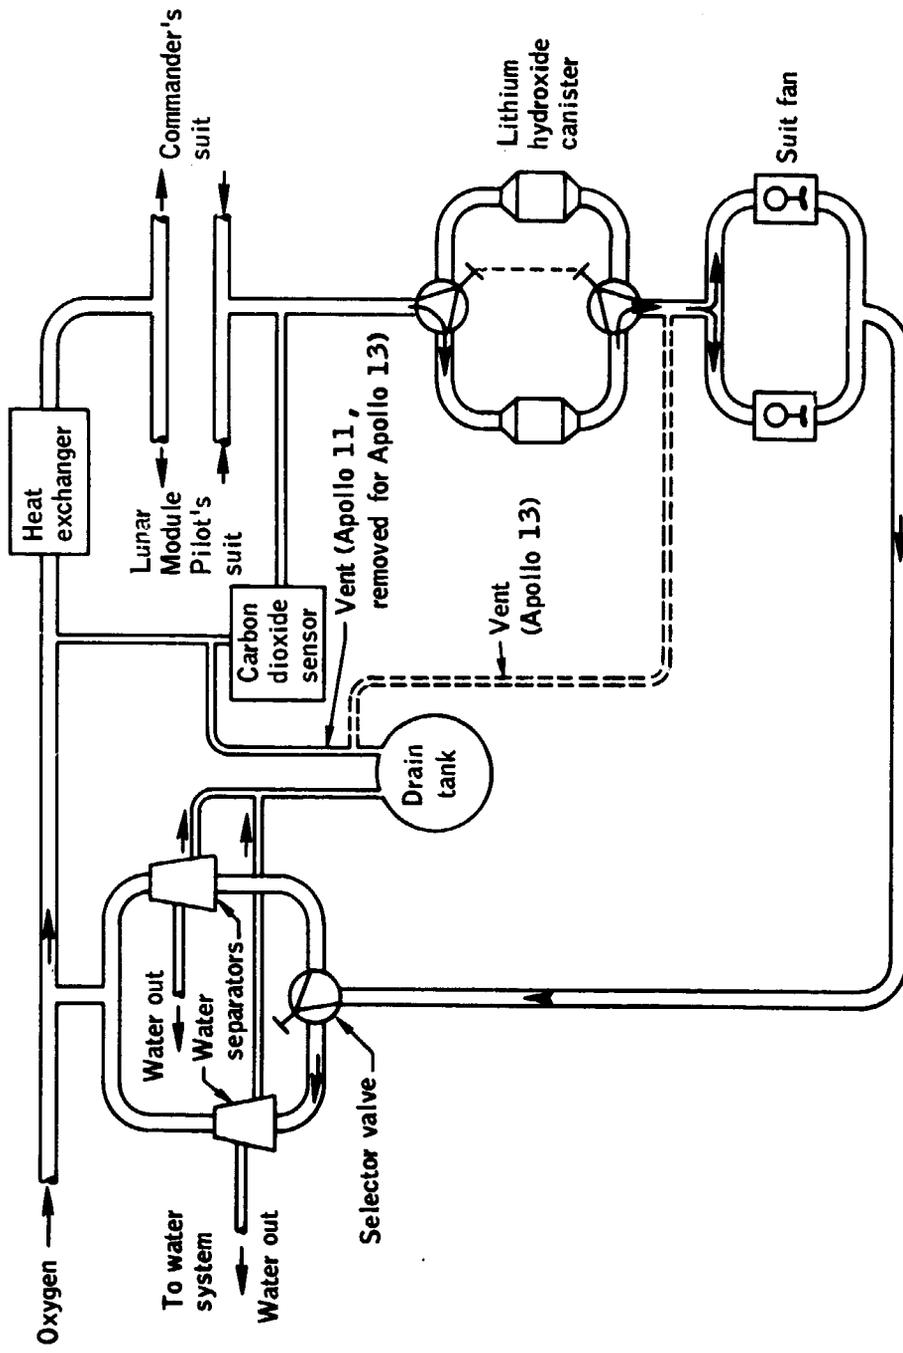
Figure 16-11.- Simplified suit loop schematic.

The possible sources of free water in the suit loop are the water separator drain tank, an inoperative water separator, local condensation in the suit loop, and leakage through the water separator selector valve. (see fig. 16-11). An evaluation of each of these possible sources indicated that leakage through the water separator selector valve was the most probable source of the free water.

To preclude water being introduced into the sensor from the drain tank, the vent line will be relocated to an existing boss upstream of the fans, effective on Apollo 13 (see fig. 16-11).

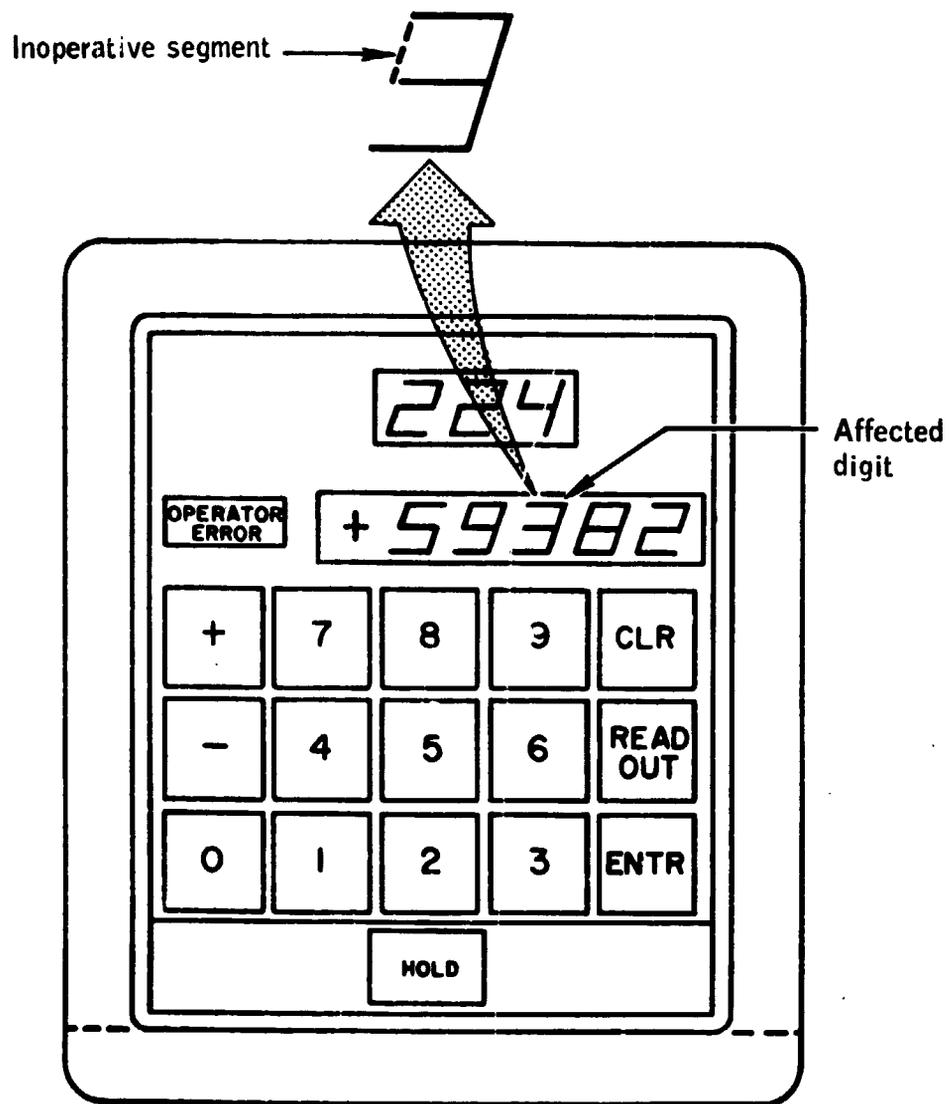
Figure 16-15.- Inoperative segment in one digit of data entry and display assembly.

An electroluminescent segment on the numeric display of the abort guidance system data entry and display assembly was reported inoperative. The affected digit is shown in figure 16-15. With this segment inoperative, it was not possible to differentiate between the numerals 3 and 9. The crew was still able to use the particular digit; however, there was some ambiguity of the readout.

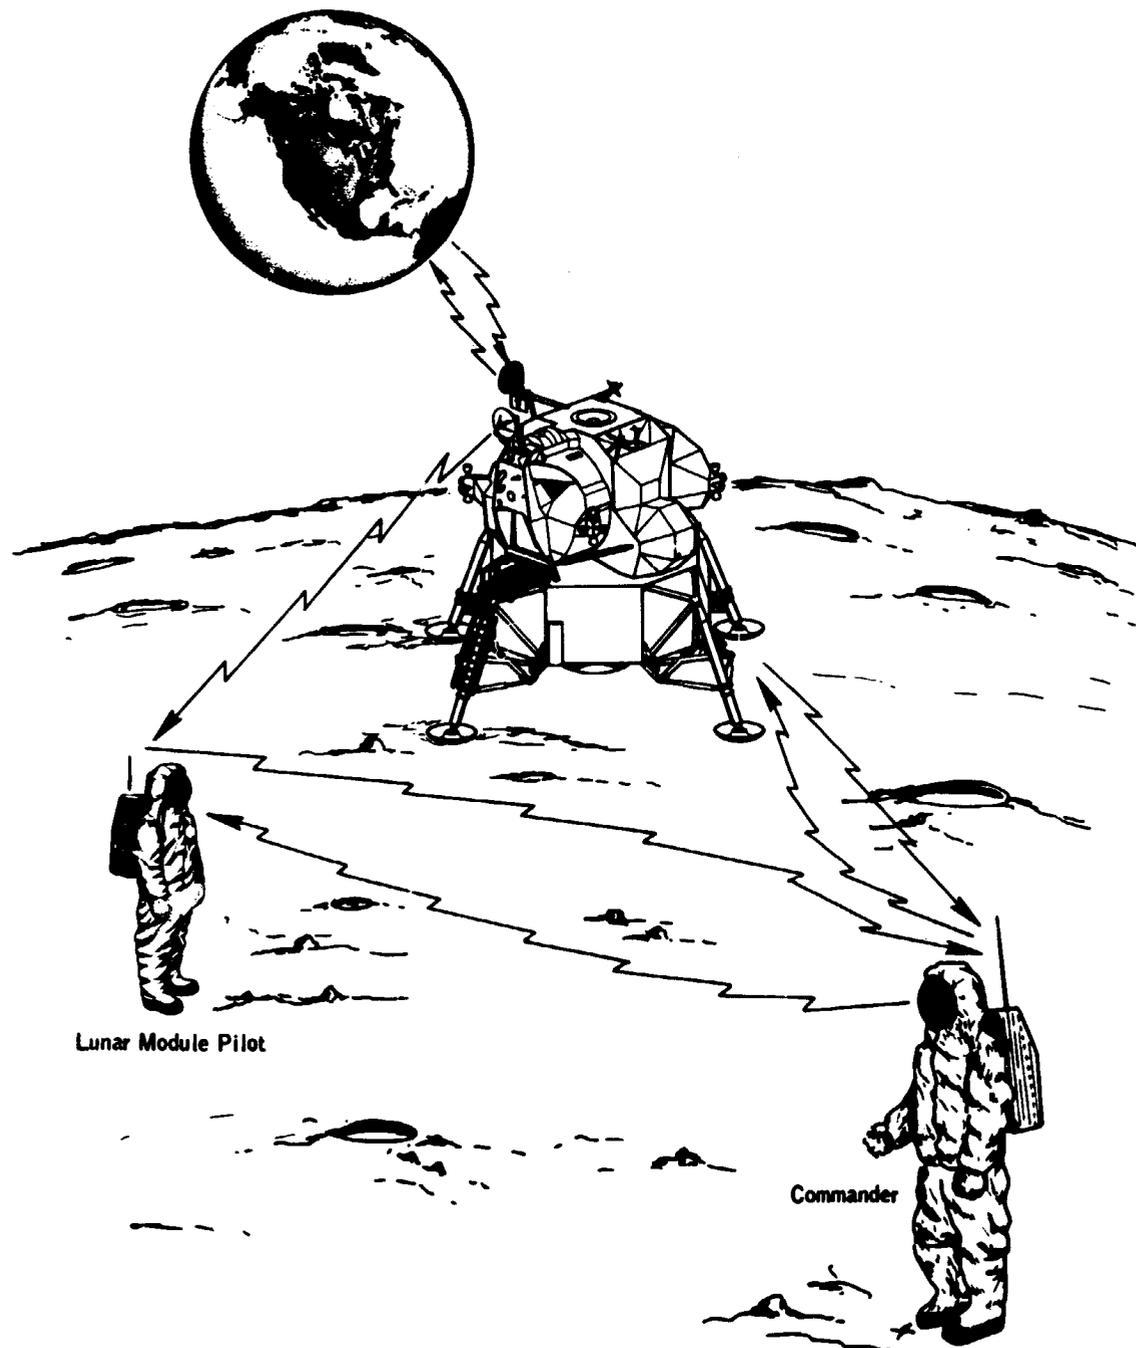
Figure 16-16.- Communications relays during extravehicular activity.

A voice turnaround (echo) was heard during extravehicular activity. At that time, the lunar module was operating in a relay mode. Uplink voice from the S-band was processed and retransmitted to the two extravehicular crewmen via the lunar module VHF transmitter. Crew voice and data were received by the lunar module VHF receiver and relayed to the earth via the lunar module S-band transmitter (see fig. 16-16). The echo was duplicated in the laboratory and resulted from mechanical acoustical coupling between the communications carrier earphone and microphone (fig. 16-17). The crew indicated that their volume controls were set at maximum during the extravehicular activity. This setting would provide a level of approximately plus 16 dBm into each crewman's earphones. Isolation between earphones and microphones, exclusive of air path coupling, is approximately 48 dB. The ground voice signal would therefore appear, at the microphone output, at a level of approximately minus 32 dBm. Assuming extravehicular communication keying is enabled, this signal would be processed and transmitted by the extravehicular communications system and would provide a level of approximately minus 12 dBm at the output of the lunar module VHF receiver. If the lunar module relay is enabled, this signal would be amplified and relayed to earth via S-band at a nominal output level.

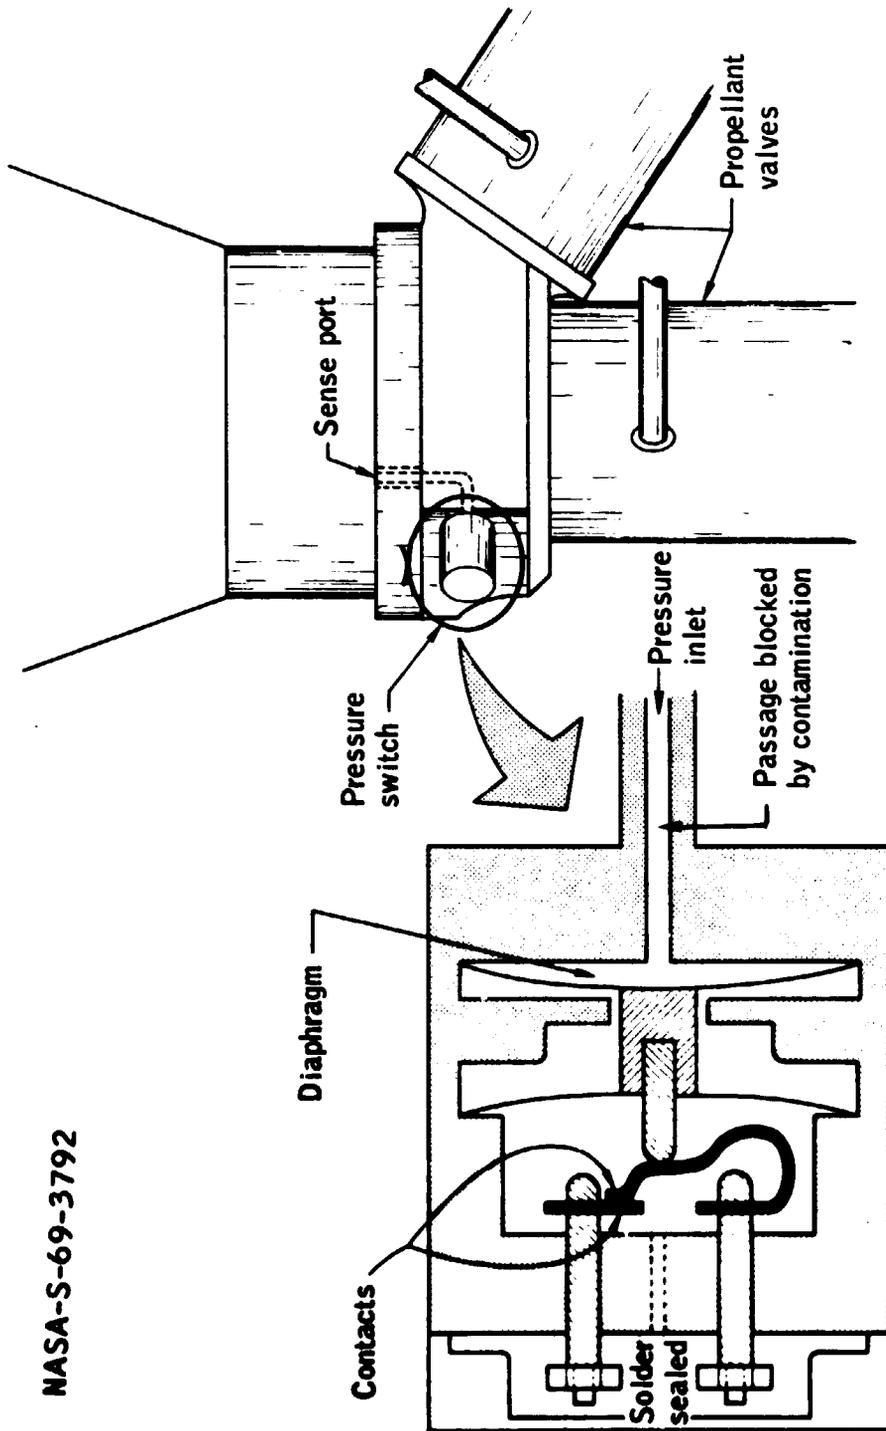
Figure 16-18.- Chamber pressure switch.

The switch used to monitor the quad 2 aft-firing engine (A2A) exhibited slow response to jet driver commands during most of the mission. During an 18-minute period just prior to terminal phase initiation, the switch failed to respond to seven consecutive minimum impulse commands. This resulted in a master alarm and a thruster warning flag, which were reset by the crew. The engine operated normally, and the switch failure had no effect on the mission. The crew did not attempt any investigative procedures to determine whether the engine had actually failed. A section drawing of the switch is shown in figure 16-18.

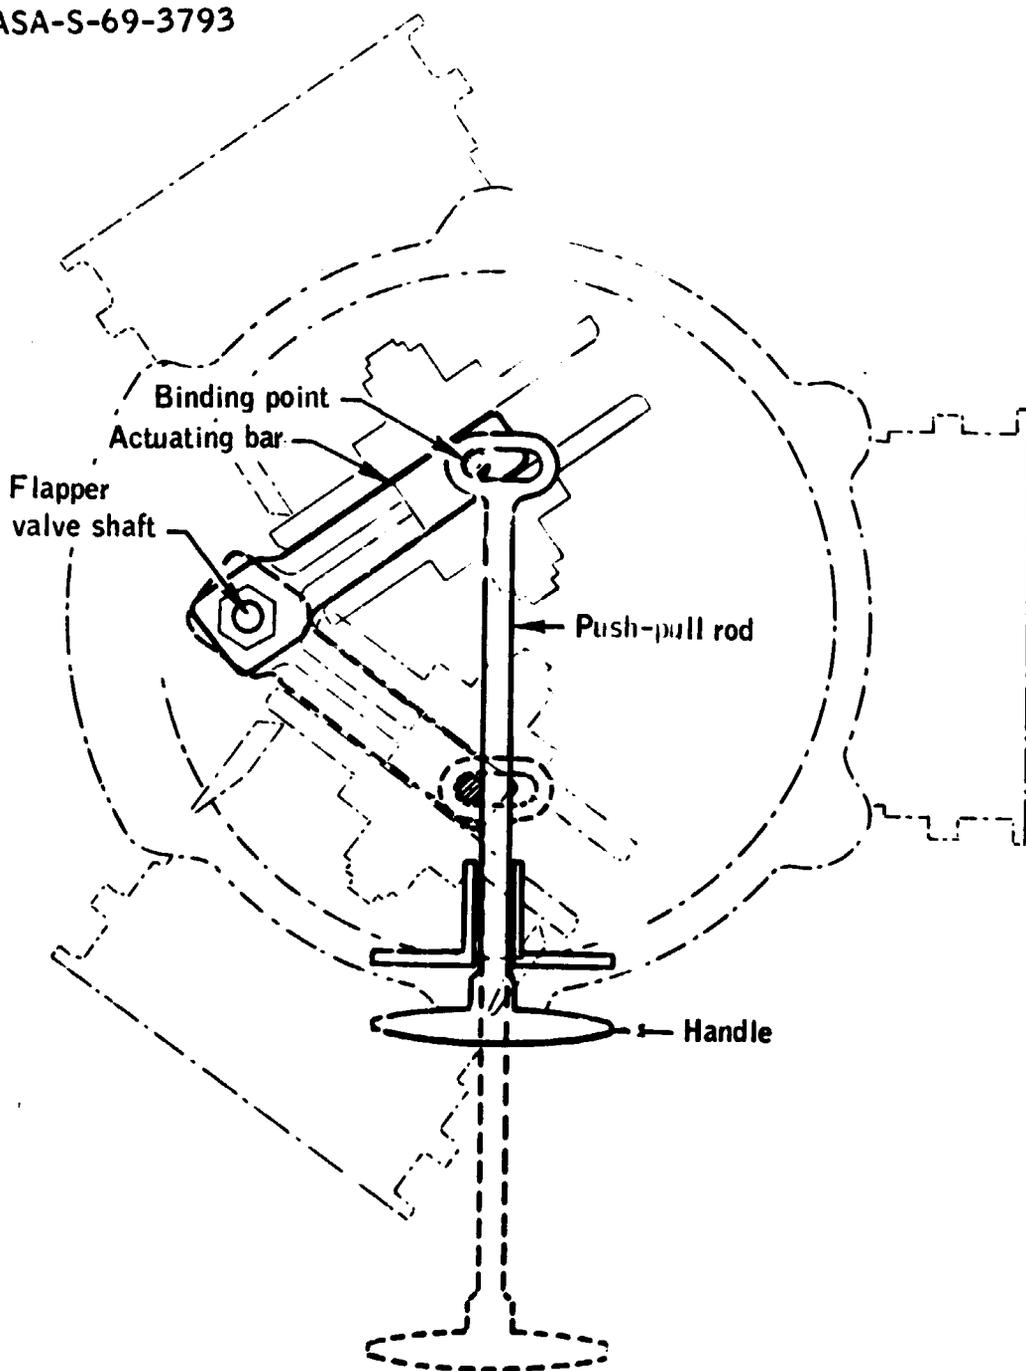
Figure 16-19.- Water separator selector valve.

The flapper type valve is located in a Y-duct arrangement and is used to select one of two water separators. Leakage of this valve would allow free water to bypass through the idle water separator and subsequently enter the suit hose. This leakage most probably resulted from a misalignment and binding in the slot of the selector valve actuation linkage (see fig. 16-19). The allowable actuation force after linkage rigging was 15 pounds. The usual actuation forces have been 7 to 8 pounds, but 12.5 pounds was required on Apollo 11. The allowable actuation force has been lowered to 10 pounds, and inspections for linkage binding have been incorporated into procedures at the factory and the launch site.

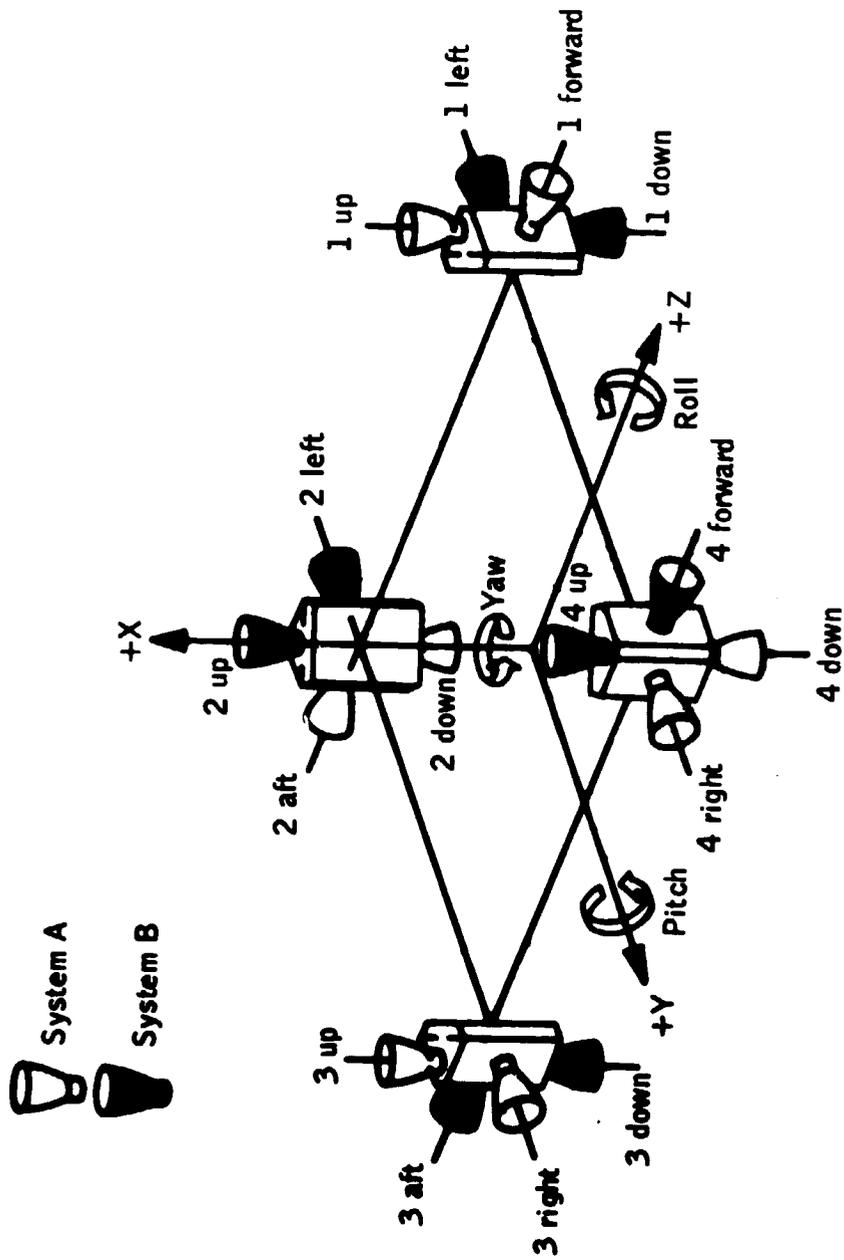
Figure 16-21.- Reaction control system geometry.

If +X translation were commanded (fig. 16-21), the down-firing engines in quads 2 and 4 of system A could fire, giving flags 2A and 4A. A subsequent minus X rotation could fire the forward-firing thruster in quad 4 of system B and the aft-firing thruster in quad 2 of system A, giving flag 4B. The aft-firing engine in quad 2 of system A (A2A) is not monitored by one of the ten buffers postulated failed. The failure then could have cleared itself. The response of the vehicle to thruster firings would have been normal under these conditions. There is no history of similar failures either at package or module level in the signal conditioner electronics assembly. No corrective action will be taken.

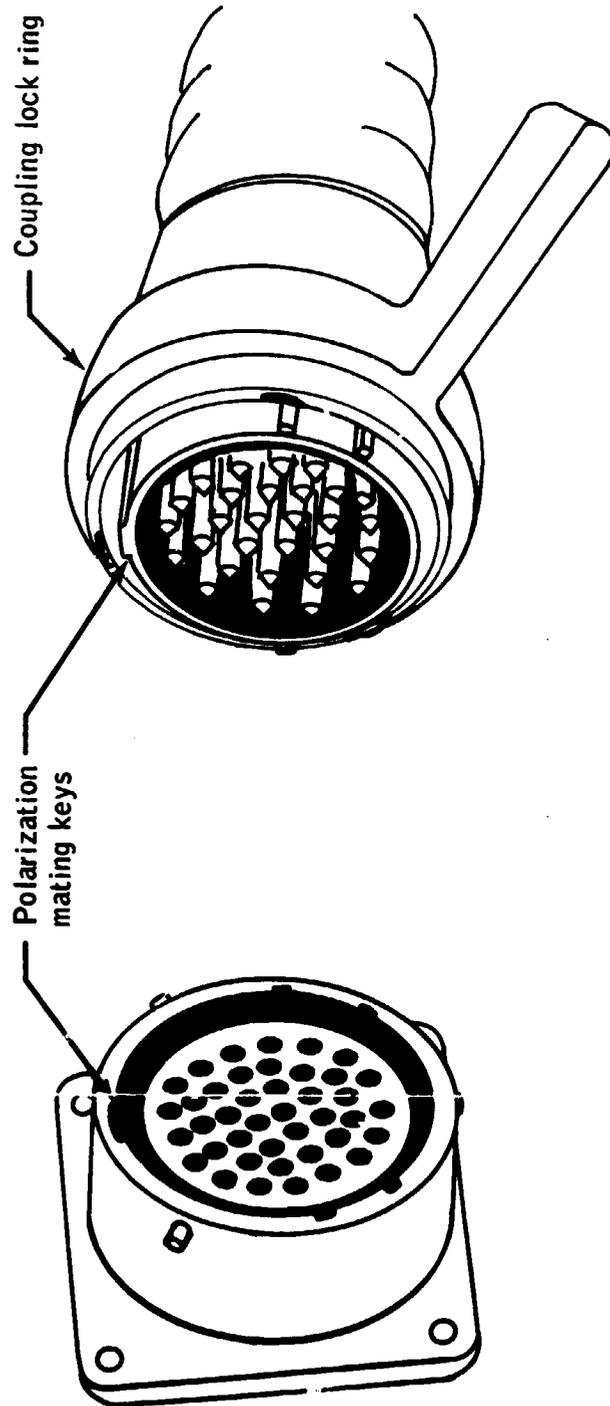
Figure 16-22.- Connector between remote control unit and portable life support system.

During preparation for extravehicular activity, the crew experienced considerable difficulty in mating the electrical connectors from the remote control unit to the portable life support system. For rotational polarization alignment, it was necessary to grasp the cable insulation because the coupling lock ring was free for unlimited rotation on the connector shell (see fig. 16-22).
